Exterior Examination of Sanctuary walls:

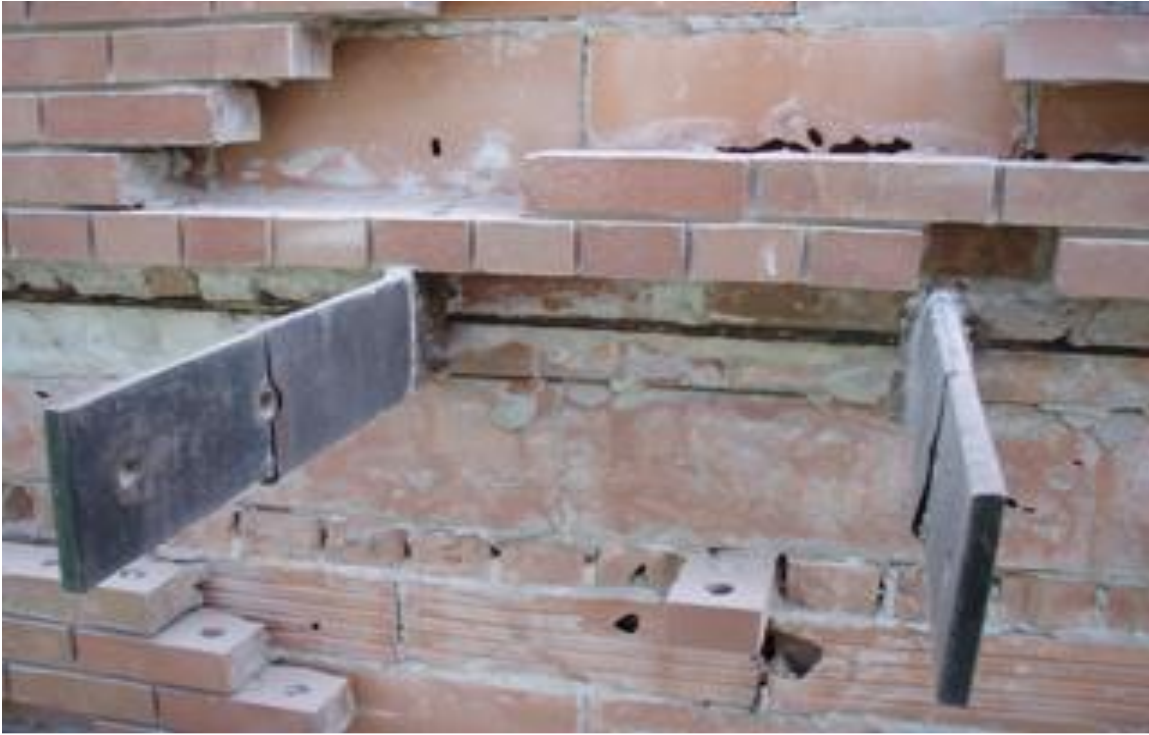
This picture highlights the wall construction of exterior brink against interior block/masonry.

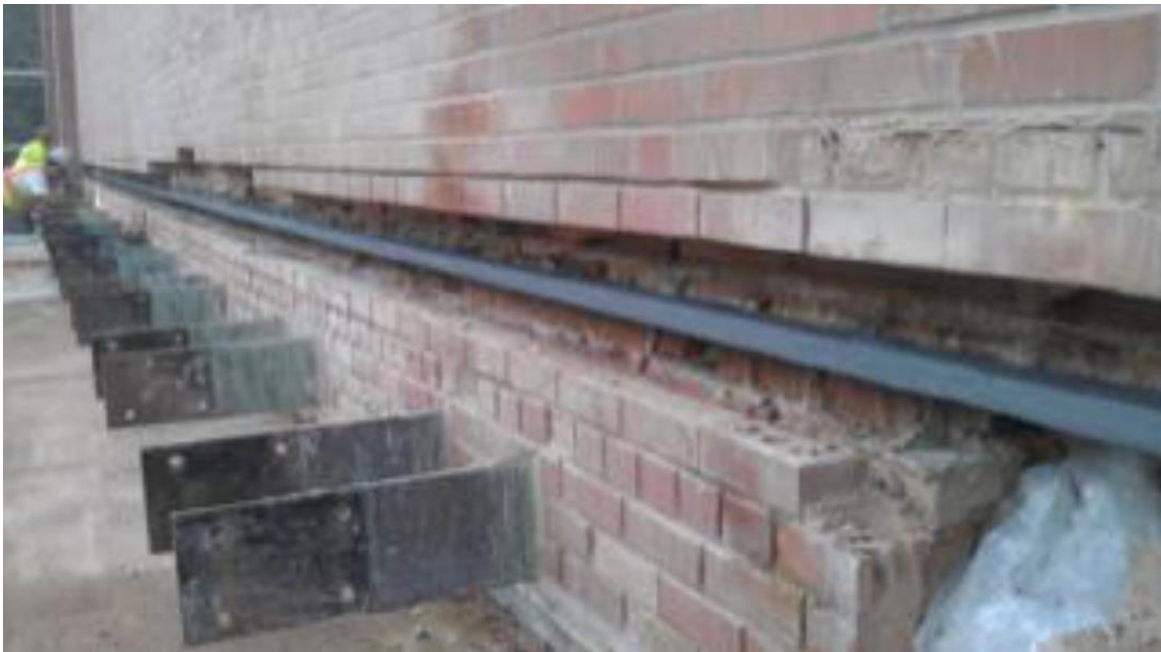
The picture below shows the the brick flaking and deterioration that takes place.

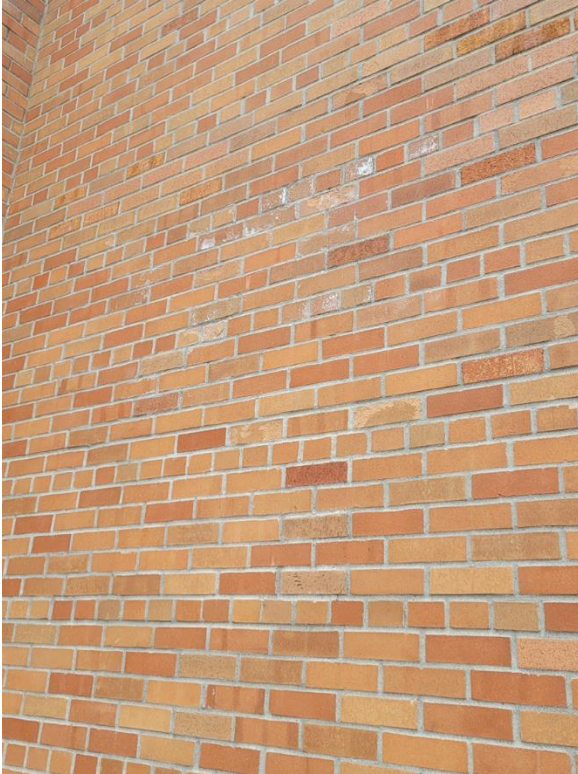
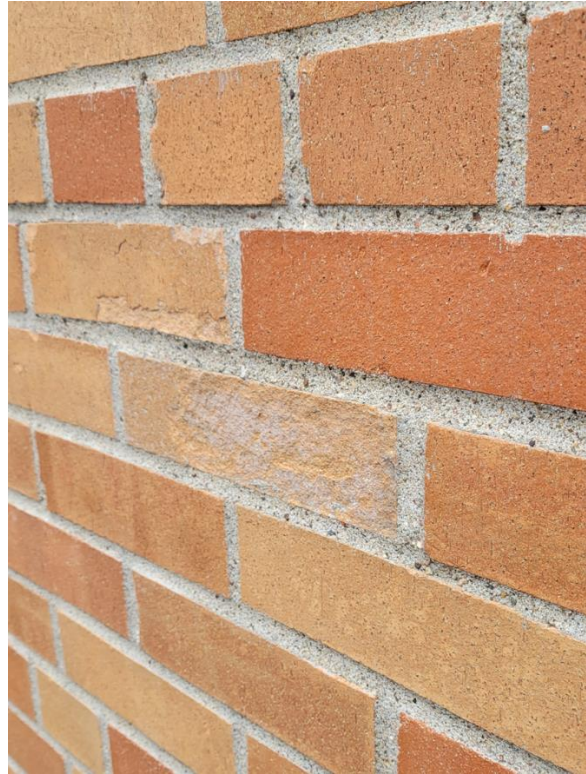
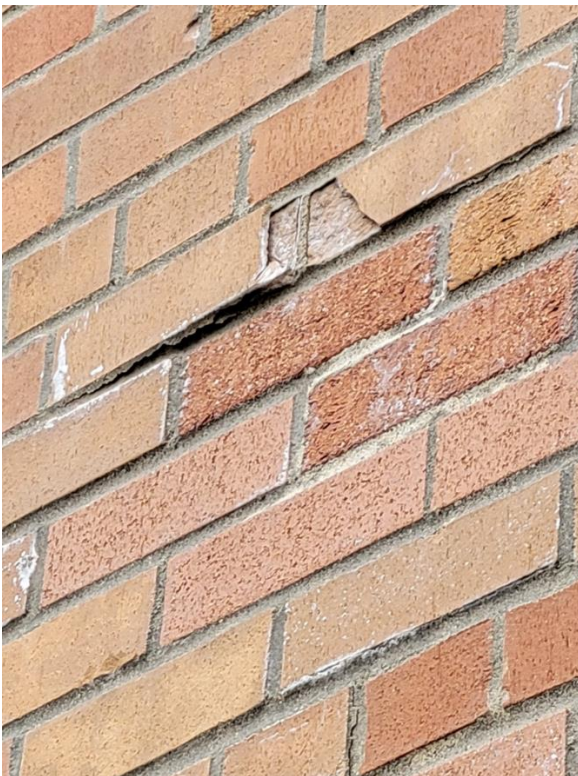
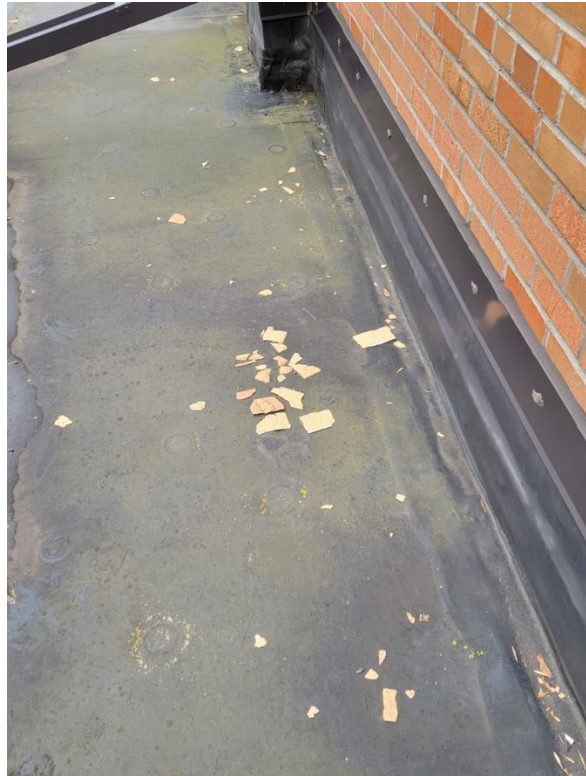
Current examples of brick flaking and brick efflorescence on the sanctuary walls.

If you look around the sanctuary you will see the ways moisture intrusion affects the interior walls.

Recommended option:
#5 EXTERIOR INSULATION AND FINISH SYSTEM (EIFS) OVERCLAD
